Memo

Project: Willamette Activity Center Study
Subject: WAC Funding Committee October Design Team Report
Date: October 28, 2022
To: WAC Funding Committee
From: Curt Wilson, AIA

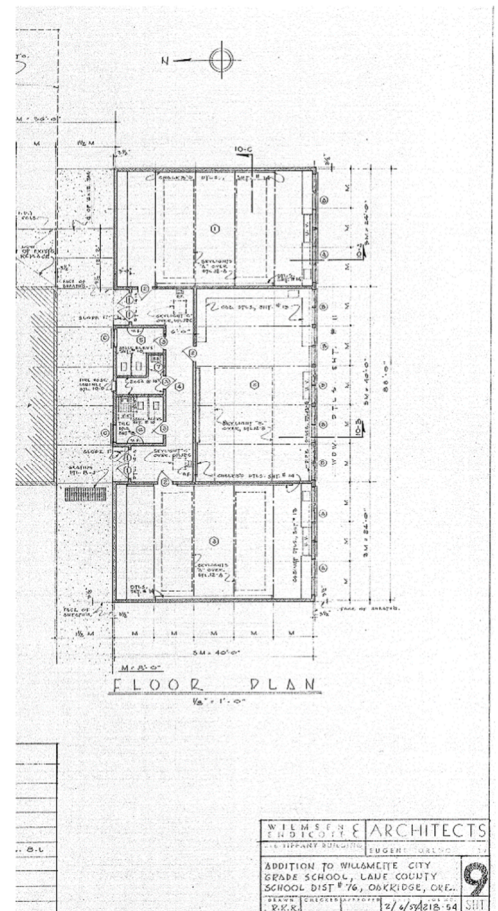
The original building included a boiler at the north end of the school. The boiler provided the heat to a hydronic system that heated the spaces. The hydronic system was a system of small diameter, closely spaced pipes embedded in the concrete slab. The pipes carried a liquid that was heated by the boiler then traveled through the pipes, radiating heat to the spaces. This is a highly efficient heating system, but the pipes from this era often failed within a few decades. The system was abandoned

and replaced with electric base board heat at some point in the past, with the exception of the courts in Building D, which were renovated in 1991. Two roof-top mechanical units with ductwork routed above the ceiling serves that space.

We recommend that subsequent tenant improvements include roof top mechanical units and duct work to replace the base board heat, as base board heat is an inefficient source of heat and does not provide fresh air ventilation. The quantity, size, weight, and location of the future mechanical units can vary significantly, therefore we don't recommend providing roof curbs for future units when the roofing is replaced. The recommended roof system can be modified and patched in the future without invalidating the warranty.

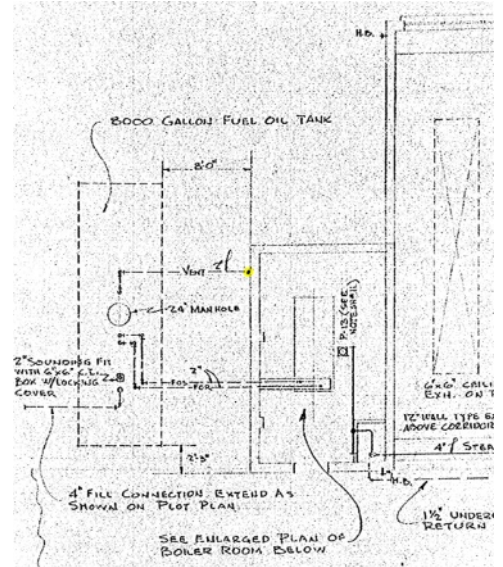
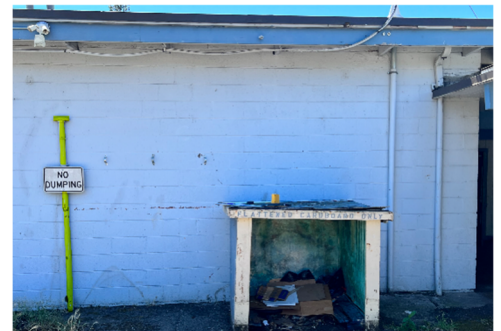
Sheet 10 of the 1952 drawing set shows the location of an 8,000-gallon fuel tank that served the boiler. Sheet 12 of the 1952 set shows a pipe vent that comes from below ground and against the building at the boiler room location. I believe that pipe is visible, which leads me to speculate that the oil tank remains. The drawings also show a manhole in that area, which I haven't found yet. We haven't discussed improvements in this area; therefore we won't encounter the tank, but the City should consider determining if the tank has been properly decommissioned.

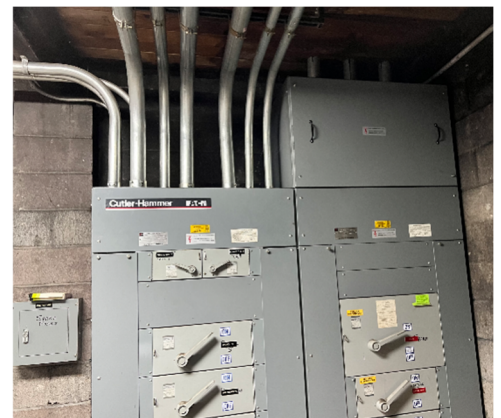
It appears that most of the electrical service was upgraded during the 1991 project. It's still in good shape and should be useful for many more years. The electrical service has an overall capacity that appears sized for the base board heat and current lighting system. The new mechanical system and new LED light fixtures should consume less power than the current systems, therefore we expect the electrical service will be sufficient for uses consistent with recent uses in the building.

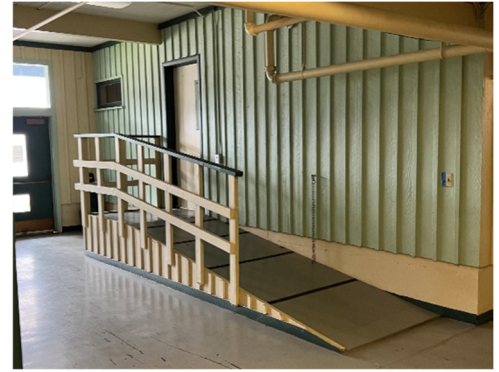
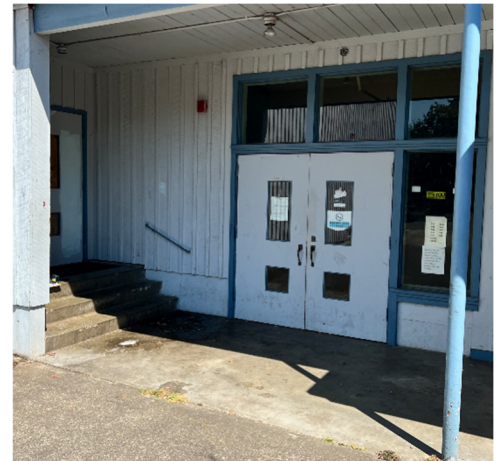
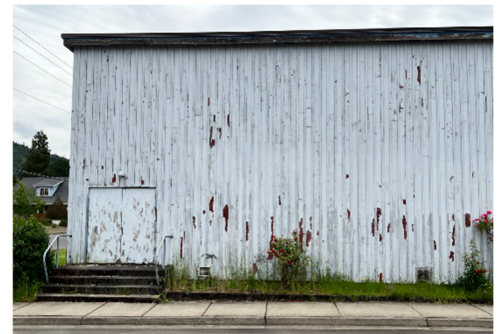
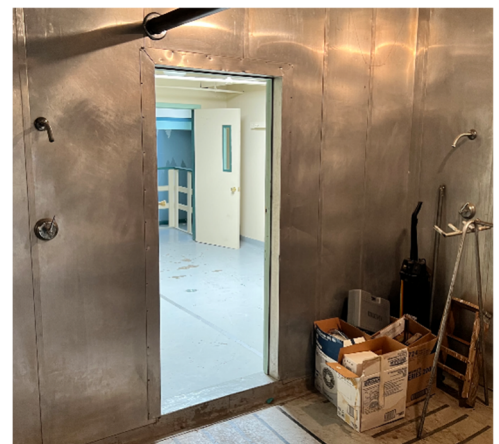
The one spatial improvement we recommend prior to occupancy and tenant improvements is improved access to the gym, stage, and food service area. This module (Module C) is elevated above the exterior grade and other spaces in the building. There are four points of access (three exterior and one interior), but none of these access points are accessible as defined by the building code, or by ADA civil rights law.

The interior ramp in the lobby area that is the interior access is too steep* and leads directly into a room with limited access to two locations. One of those locations is a group shower with raised curbs at doors, therefore not accessible, and the other direction leads to a restroom. The east access into the hall that leads to the kitchen is a sloping surface that is also too steep and does not meet the code requirements for landings.

* The maximum include for an accessible ramp is 1 unit vertically for every 12 units horizontally. For example, an elevation change of 1 ft would require a ramp horizontal length of 12 feet. The elevation change from the lobby to the gym level is approximately 21 ½ inches, therefore an appropriate ramp length of 21 ft., 6 in. is required. The current ramp is about 11 ft, 6 in.

The gym area is one of the more public areas of the building, therefore providing appropriate accessibility for everyone is important. Improvements to that module will mandate improved access. The building code mandates that at least 51% of required exits be accessible, therefore priority improvements should include providing ramps in at least two locations.

A ramp from the concrete landing at the west entrance can be added to the south of the landing and integrated with the sidewalk at the bottom.

I recommend replacing the existing ramp in the lobby with a ramp of an appropriate slope, which will require about twice the length of the current ramp. In addition, the spaces from the top of the ramp should be modified to provide an accessible path to the gym, kitchen, and dressing rooms without passing through other spaces. This will probably impact the existing restroom south of the stage, which is an opportunity to better utilize the spaces east of the stage.

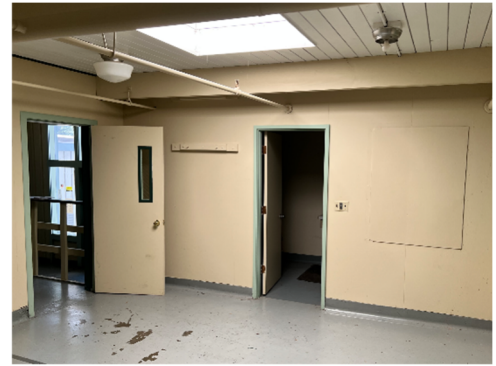
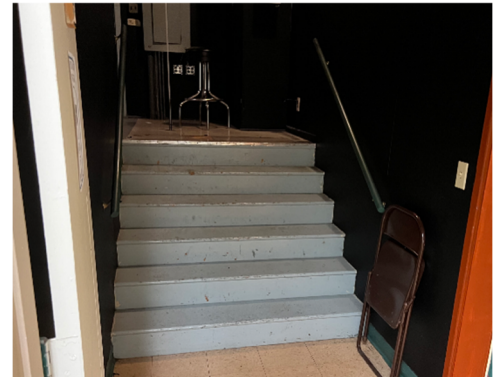
The stage is located at an elevated level as well. The building code will not mandate providing access to the stage as a base requirement for improvements of Module C, but use of the stage should be evaluated for ADA compliance and risk to the city. Options to access the stage, including motorized lifts should be evaluated. For reference, the stage is slightly more than 44 in. above the gym level, therefore a ramp of more than 44 ft would be required.
