Final Report for

Oakridge Pedestrian Safety Study

February 2016

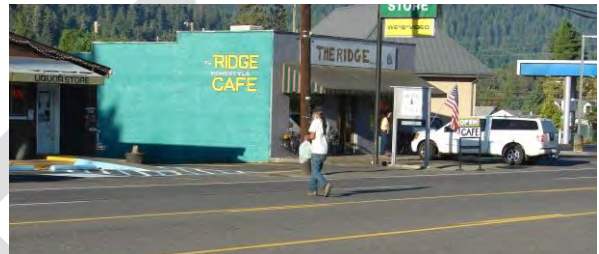
PEDESTRIANS CROSSING OR 58 NEAR ROCK ROAD

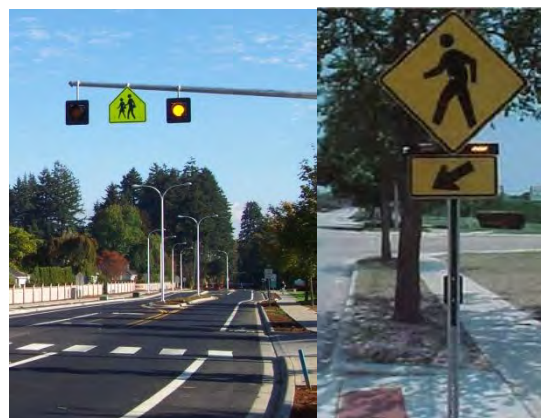
**PEDESTRIAN TOOLBOX EXAMPLE TREATMENTS
(ON LEFT: OVERHEAD FLASHING BEACON;
ON RIGHT: RRFB SIGN ASSEMBLY)**

To assist in the selection of recommended conceptual crossing treatments, a toolbox of available pedestrian crossing treatments was prepared and refined to include only those treatments that were considered feasible for the OR 58 corridor. Two example strategies, such as overhead flashing beacons and rapid rectangular flashing beacons (RRFB) with warning signage, are shown below. See Chapter 3 (Crossing Treatment Toolbox) for the complete list of treatments.

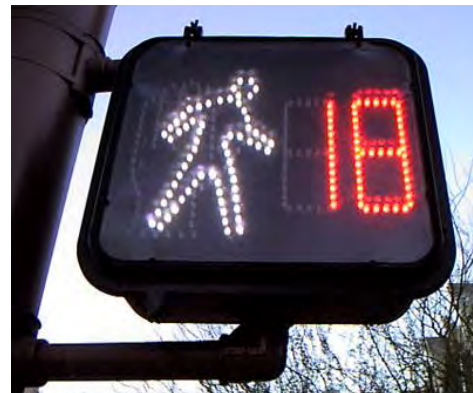
Example of Pedestrian Countdown Timer

An example of pedestrian countdown timers is shown below. See Chapter 4 (Pedestrian Improvement Design Concepts) for the complete list of treatments.

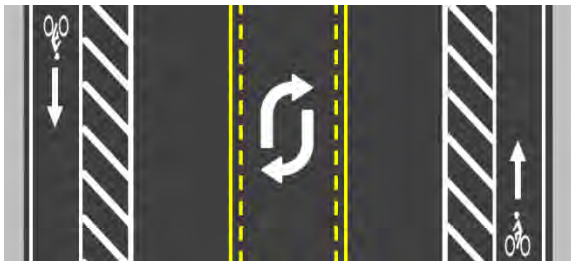
A conceptual design of the proposed three-lane cross sections along OR 58 is shown below. It is important to note that extensive medians were not considered as part of this project.

Five- To Three-Lane Conversion Concept

Details regarding potential OR 58 lane conversions can be found in Chapter 5.

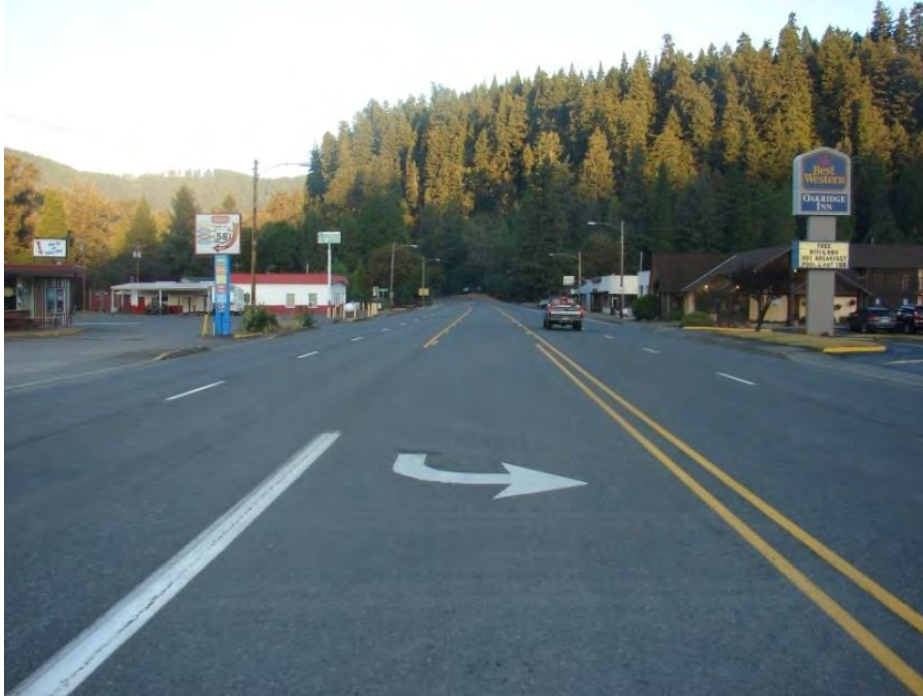
The majority of OR 58 is a five-lane road with a two-way left turn lane as a center lane (see photo below). Portions of OR 58 consist of a narrower four-lane section with no two-way left turn lane. There are intermittent sidewalks along the majority of the existing study area roadway. There are no marked bicycle lanes on OR 58 within the study area.

CROSS SECTION OF OR 58 NEAR 2ND STREET/RIVER ROAD

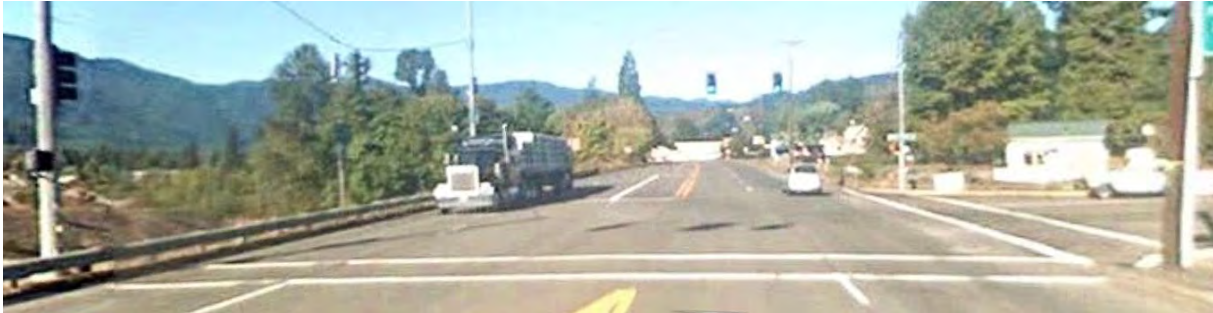
OR 58/CRESTVIEW STREET CROSSWALKS

The existing pedestrian facilities were previously shown in Figure 2-1 along OR 58. The facilities consist of discontinuous sidewalks, widened shoulders, and gravel or dirt paths that include various obstructions such as utility poles and driveways. There is one signalized intersection along OR 58 at Crestview Street that provides signalized pedestrian crossings with marked crosswalks. However, the crosswalk on the east leg of the intersection leads to a guardrail where pedestrians have no sidewalk or shoulder along the highway, as shown in the photo below.

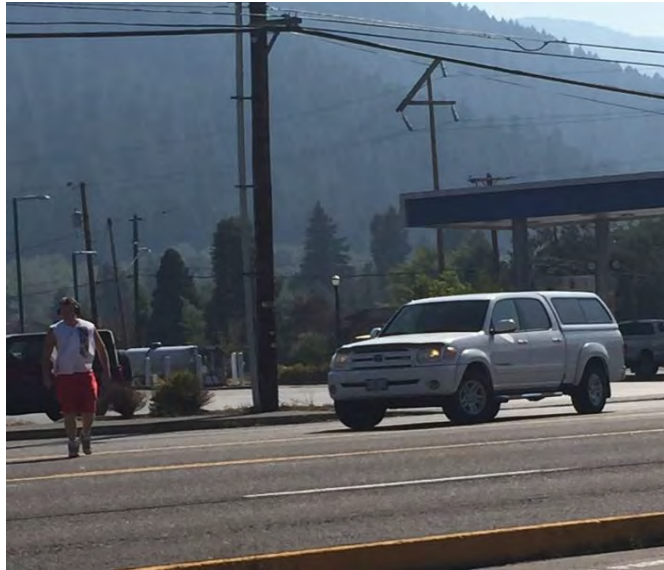
PEDESTRIAN-VEHICLE CONFLICT NEAR RAINBOW ROAD ON OR 58

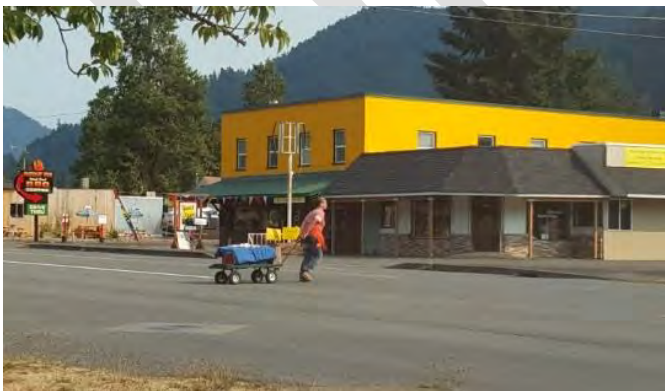
PEDESTRIAN CROSSING AT THE 2ND STREET/OR 58 INTERSECTION

The observed activity and patterns for each location are discussed in the following sections. Figure 2-4 shows a summary of issues that were observed along the study area between pedestrians and vehicles. Along OR 58, pedestrians must cross five lanes and vehicles may stop in one lane and block other vehicle's vision and the

vision of the pedestrian. Vehicles that wish to turn onto OR 58 from Union Street, Rainbow Road, and other access streets must look for vehicles in both directions in addition to pedestrians crossing both at intersections and midblock locations. At OR 58 and Union Street and Or 58 and Rainbow Road there are now marked crosswalks across OR 58. Additionally, several pedestrians chose to cross at the midblock locations. Due to the lack of bicycle lanes along OR 58, cyclists will ride on the sidewalk which creates conflicts between bicyclists and pedestrians.

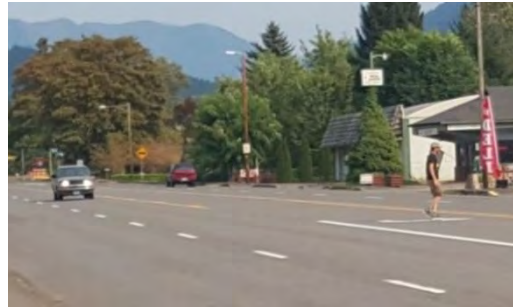
PEDESTRIAN CROSSING HWY 58 AT 2ND STREET/RIVER ROAD

Near the 2nd Street/River Road intersection, sidewalks are present on the north side of the road. There is not a marked crosswalk across OR 58 in the vicinity, which led to pedestrians crossing at numerous midblock locations. There are also access points leading to empty parking lots near the intersection that are used by freight trucks as parking. Although motor vehicle traffic volumes are relatively low, the speed limit is 35 mph (the 85th percentile speed indicates that the majority of traffic is traveling at 41 mph in this segment of the highway) and the percent of heavy vehicles is 15%-20% throughout the day.

There were very few pedestrians crossing at the intersection of OR 58 and 2nd Street/River Road when school was in session and even fewer during the summer. 2nd Street crosses the railroad tracks and provides access to the schools to the north of OR 58. Most pedestrian crossings that occurred near the unsignalized 2nd Street/River Road were made by adults during the mid-day and p.m. peak hour. The photo above shows a pedestrian crossing OR 58 at the intersection. There were also occasional pedestrians that crossed in the vicinity of the Best Western Hotel between McAtee Road and 2nd Street/River Road.

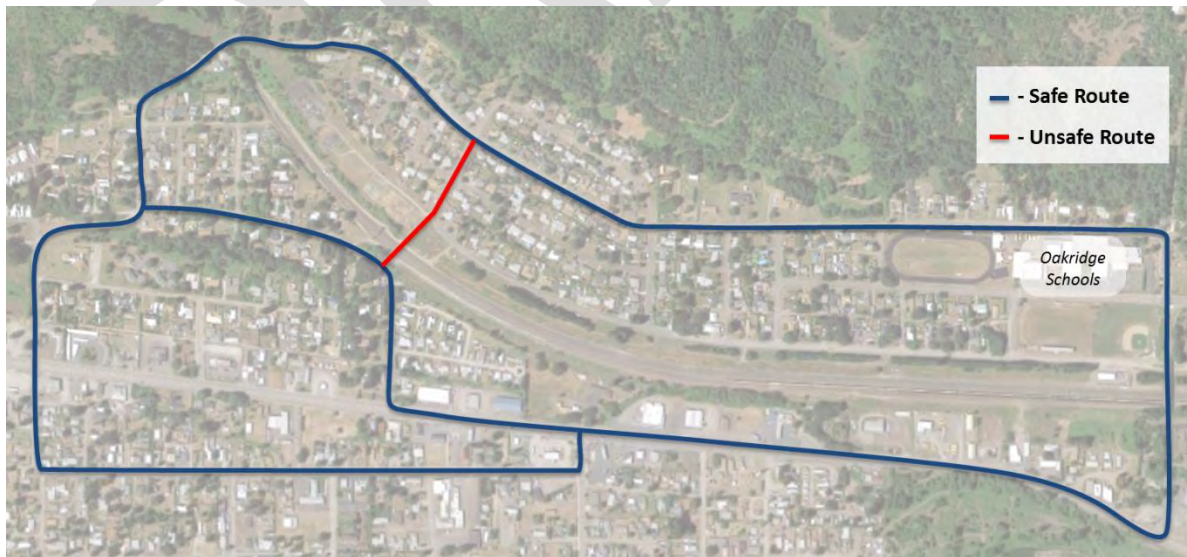
This location was only observed when school was in session primarily because of the unmarked dirt path that crosses over the railroad tracks and connects to the schools as shown by the red line in Figure 2-5. Most pedestrian activity on the Highway at this location was adults and teenagers. Crossing the Union Pacific Railroad (UPRR) on foot is illegal and is not desired. The City is considering building a pedestrian bridge over the UPRR tracks near Commercial Street and South Diamond Street to provide pedestrians traveling to and from school a more direct, safe, and legal crossing.

FIGURE 2-5: SCHOOL WALKING ROUTES

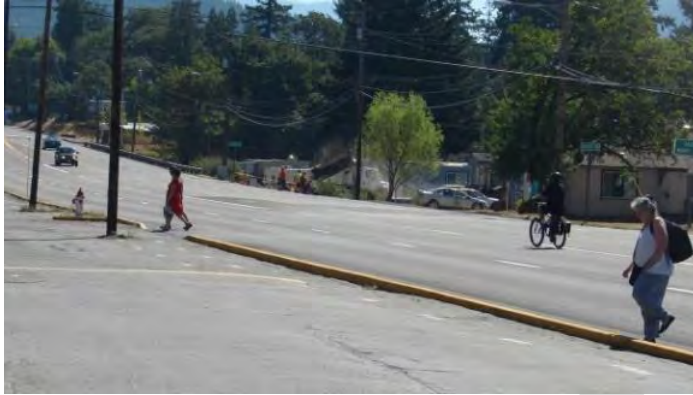
PEDESTRIANS CROSSING OR 58 NEAR ROCK ROAD

The majority of pedestrian activity at this location occurred during the summer. Most crossings were northbound and occurred during the mid-day peak period from 11 a.m. to 1 p.m. This is likely due to the food and convenience stores that are located near the OR 58 and Rainbow Road intersection. The photo shows two

different pedestrians crossing OR 58 and a cyclist riding in the median of the road. Although motor vehicle traffic volumes are relatively low, the speed limit is 35 mph (the 85th percentile speed indicates that the majority of traffic is traveling at 42 mph in this segment of the highway) and the percent of heavy vehicles is 15%-20% throughout the day. As previously discussed, this location is currently being considered for a new crosswalk as well as a rectangular rapid flash beacon (RRFB).

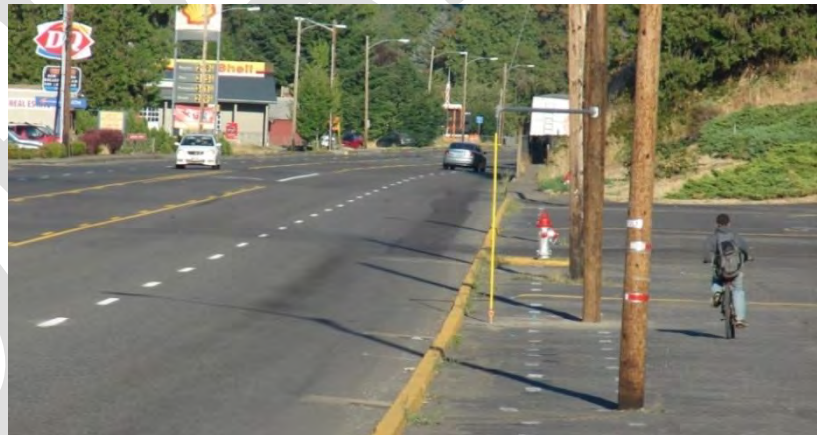
BICYCLIST RIDING ALONG PRIVATE PARKING LOT

It was observed that there was very little bicycle traffic on the Highway during the summer. A total of 5 bicycles were observed during the day that often rode on the sidewalk. The photo below shows a child riding along an area that is within a private parking lot, likely because the road does not have designated bicycle lanes. Bicyclists on the sidewalk present several safety issues for pedestrians and the bicyclists themselves. Pedestrians aren't

always capable of responding quickly to cyclists on sidewalks, especially elderly pedestrians or those with pets or strollers. Because of this, bicycle/pedestrian crashes have the potential to result in minor injuries. Furthermore, bicyclists traveling on the sidewalks are difficult for motor vehicles to see when they are riding behind trees, parked cars and other objects.

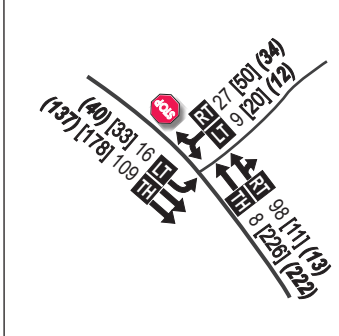
4. OR 58 @ Hills St.

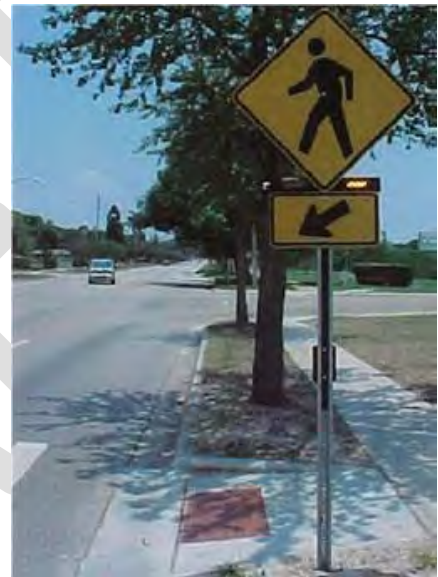
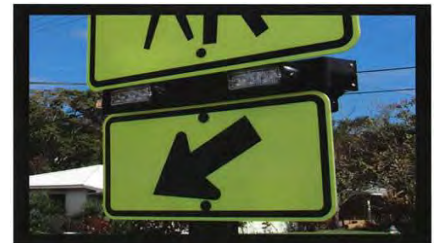
EXAMPLES

Installing a RRFB with a median on a three or more lane roadway reduces all severity types of pedestrian crashes by 56%. Without a median, all severity types of pedestrian crashes are reduced by 10%.

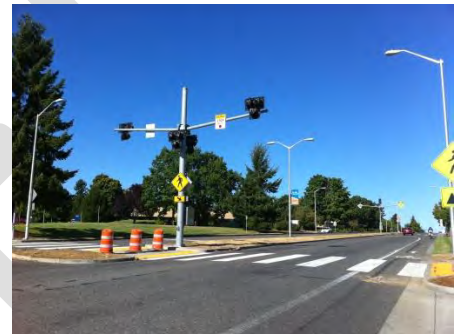
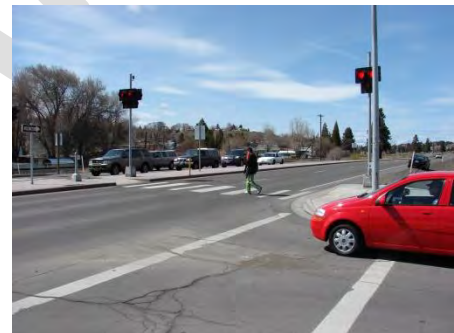
EXAMPLES

Installing a HAWK all severity types of bicycles and pedestrian crashes by 69%.

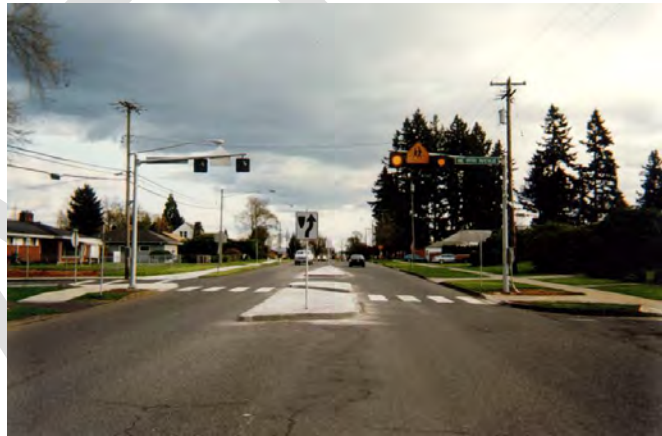
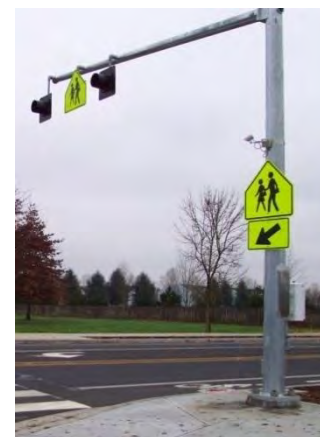
EXAMPLES

Installing an Overhead Flashing Beacon (standard and RRFB) all severity types of pedestrian crashes by 10%. If a median is installed at the same time as the Overhead Flashing Beacon, crashes are reduced by 56%.

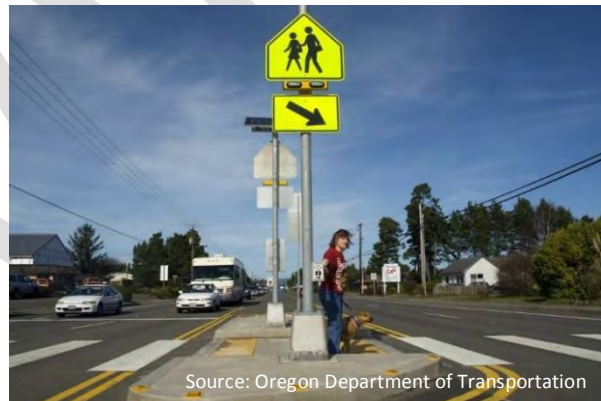
RRFB ON A PEDESTRIAN REFUGE ISLAND

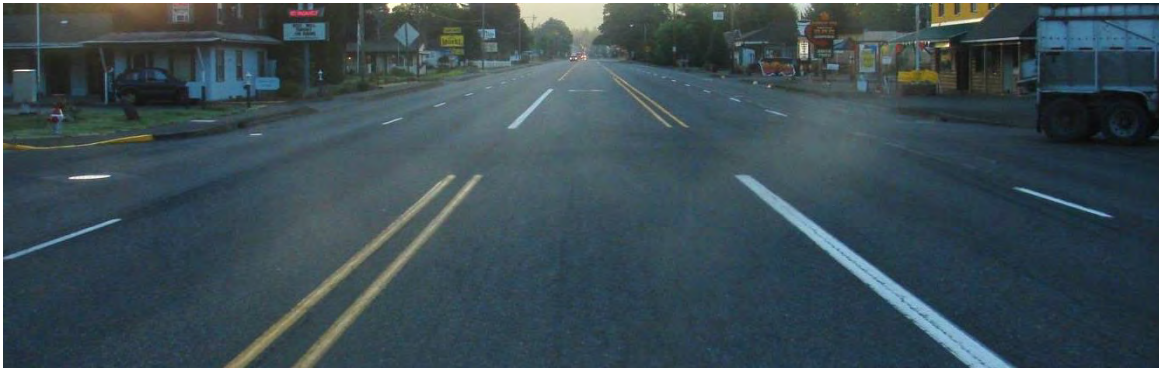
TYPICAL CROSS-SECTION OF OR 58

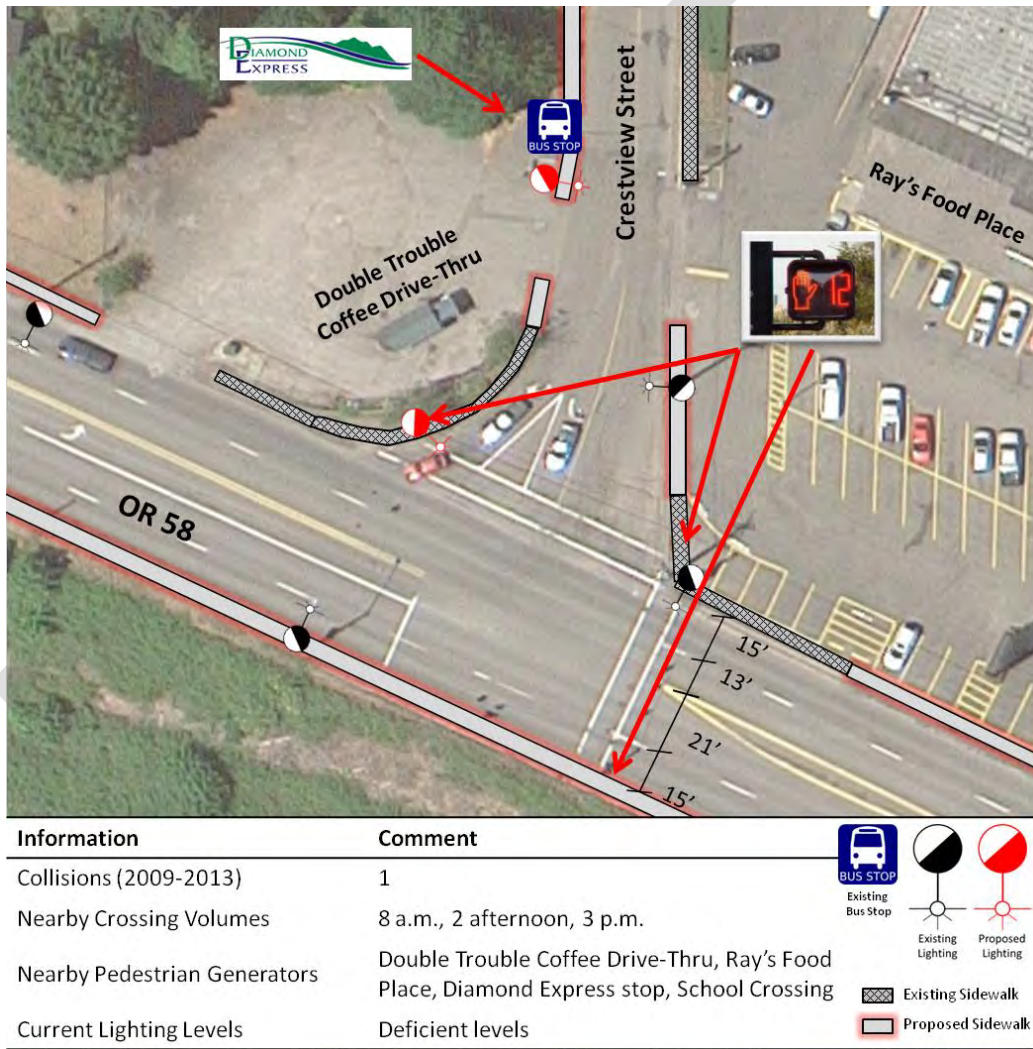
The intersection improvements needed for this location include intersection lighting, pedestrian countdown timers, and improved sidewalk near the intersection as shown in Figure 4-8. Two new standalone street lights are recommended to the west of the intersection. It is also recommended that the signal controller be upgraded to a 2070 controller to allow for the removal of conflict points between vehicles and pedestrians during the permissive eastbound left turn vehicle movement.

FIGURE 4-8: OR 58 AND CRESTVIEW STREET INTERSECTION IMPROVEMENT NEEDS

There is one signalized intersection within the study area where observed intersection safety improvements are needed; the OR 58/Crestview Street intersection.

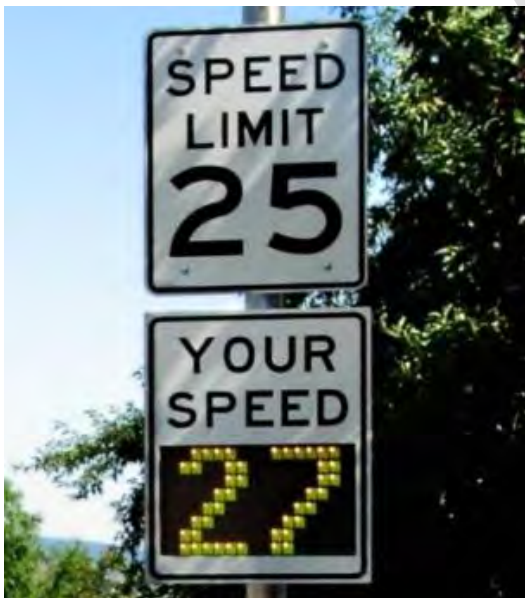
Speed feedback signs are low-cost treatments that have been shown to reduce traffic speeds, particularly along roadways where travel speeds commonly exceed the posted speed limit.²⁸ FHWA studies show that 85th percentile motor vehicle travel speeds could be reduced by five to ten percent in the event of a speed feedback sign installation.²⁹

SPEED FEEDBACK SIGN

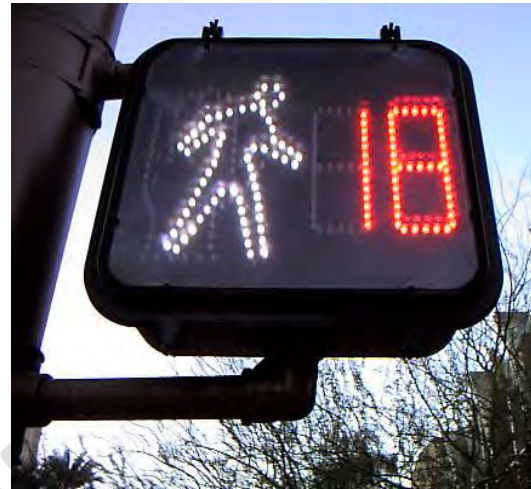
EXAMPLE OF A PEDESTRIAN COUNTDOWN

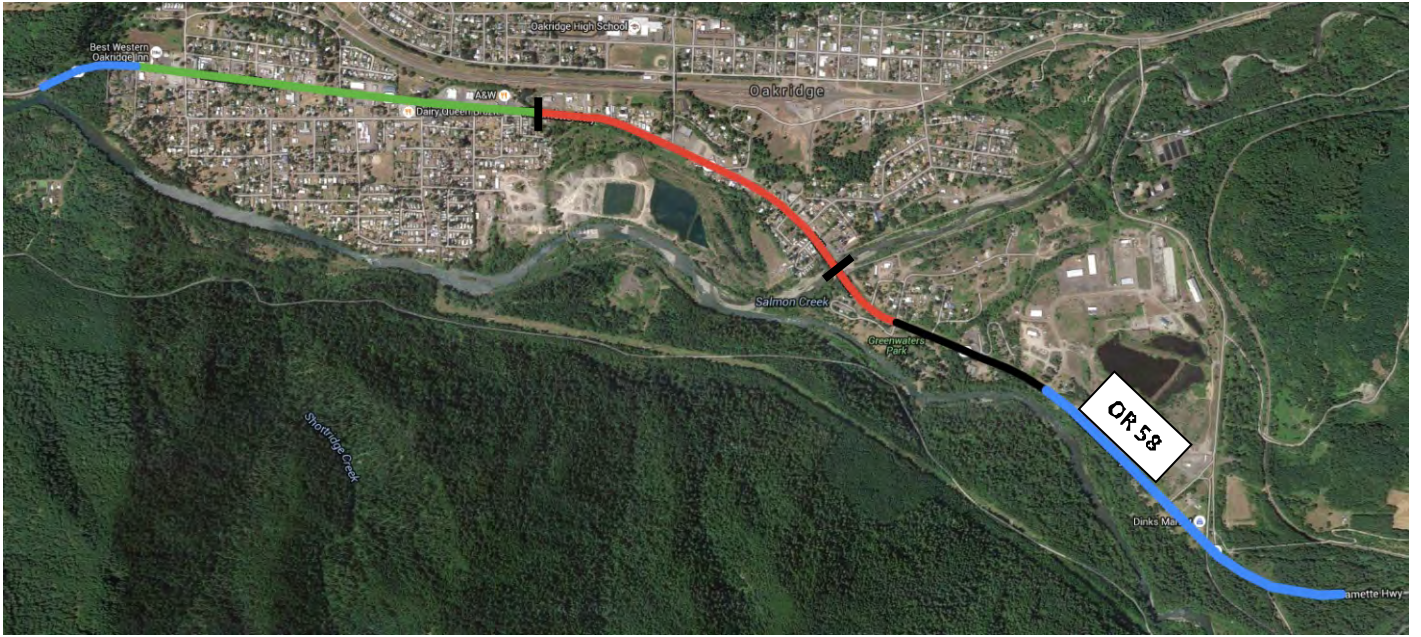
2-Lane

3-Lane

4-Lane

5-Lane
